# Suggested Practices for Avian Protection On Power Lines: The State of the Art in 2006

PIER FINAL PROJECT REPORT CEC-500-2006-022

Avian  
Power  
Line  
Interaction  
Committee

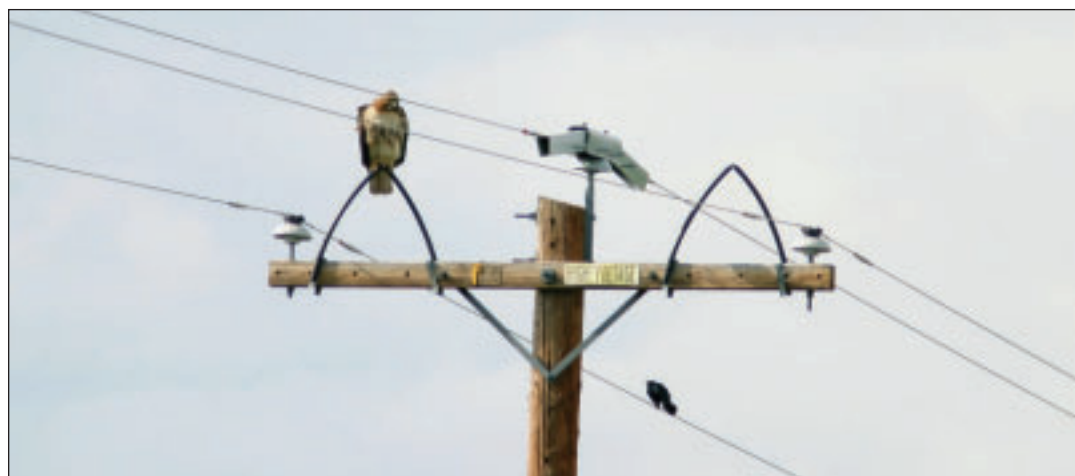
**FIGURE 2.5:** Perch discouragers have been installed on utility poles to prevent raptors or corvids from preying upon sensitive species. However, this is not recommended, as perch discouragers are intended to manage where birds perch, not to entirely prevent perching.

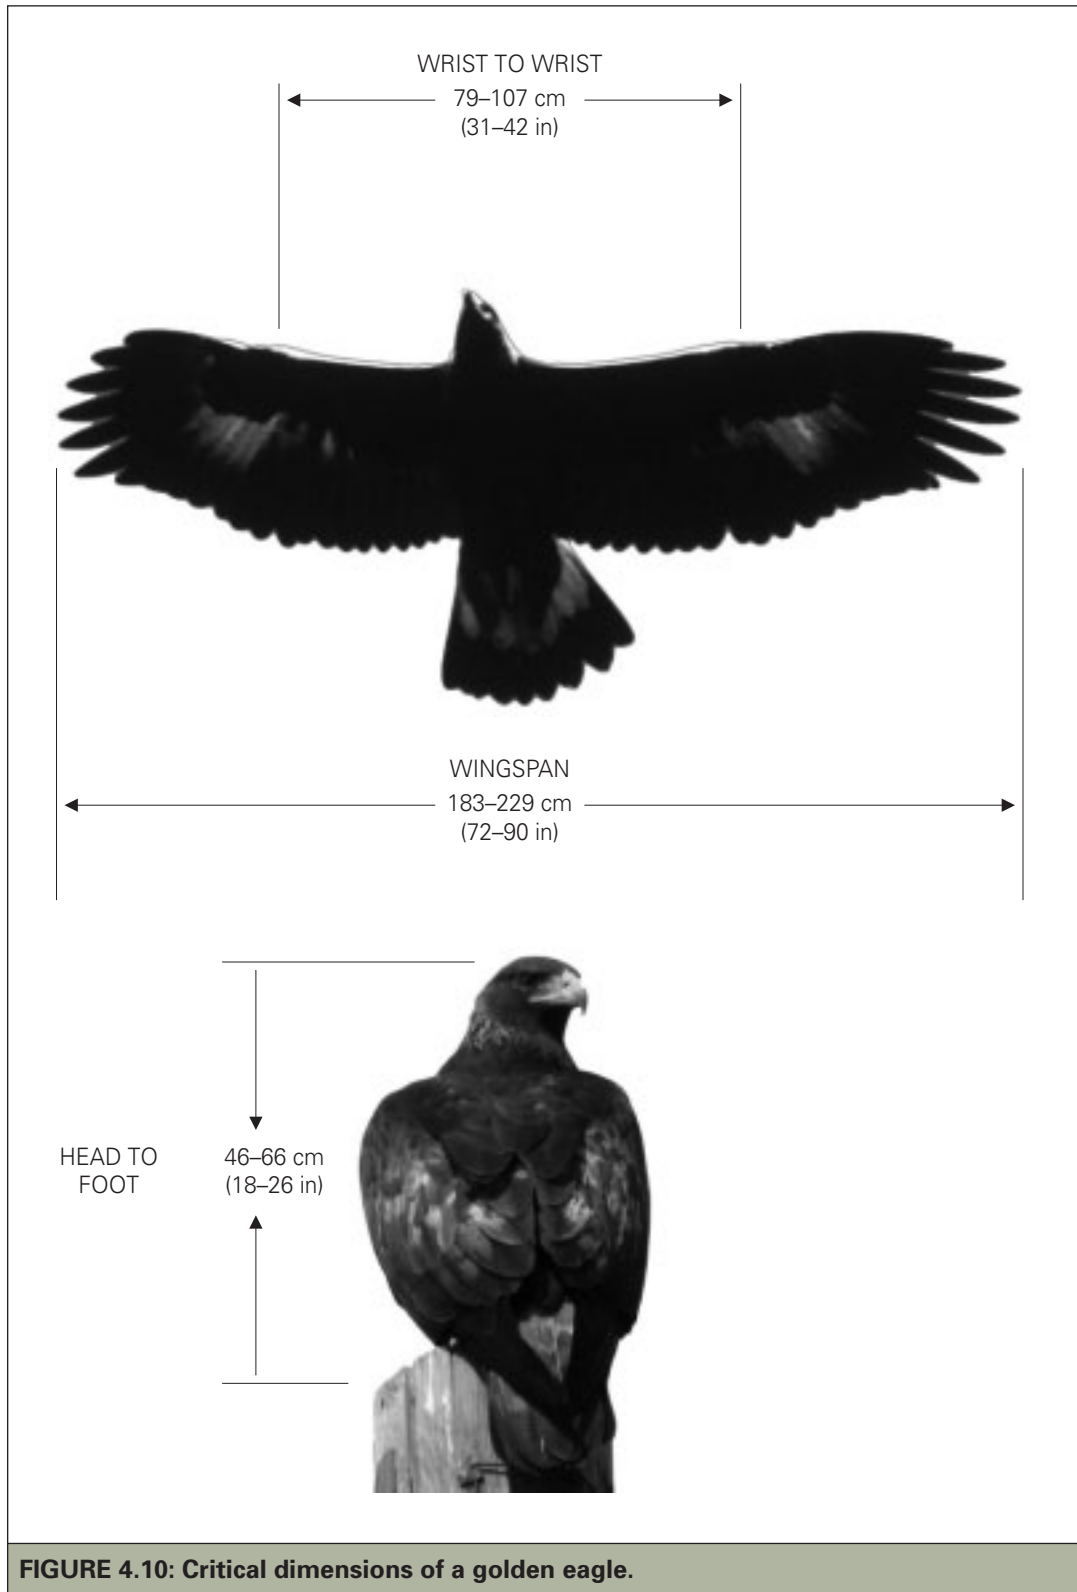
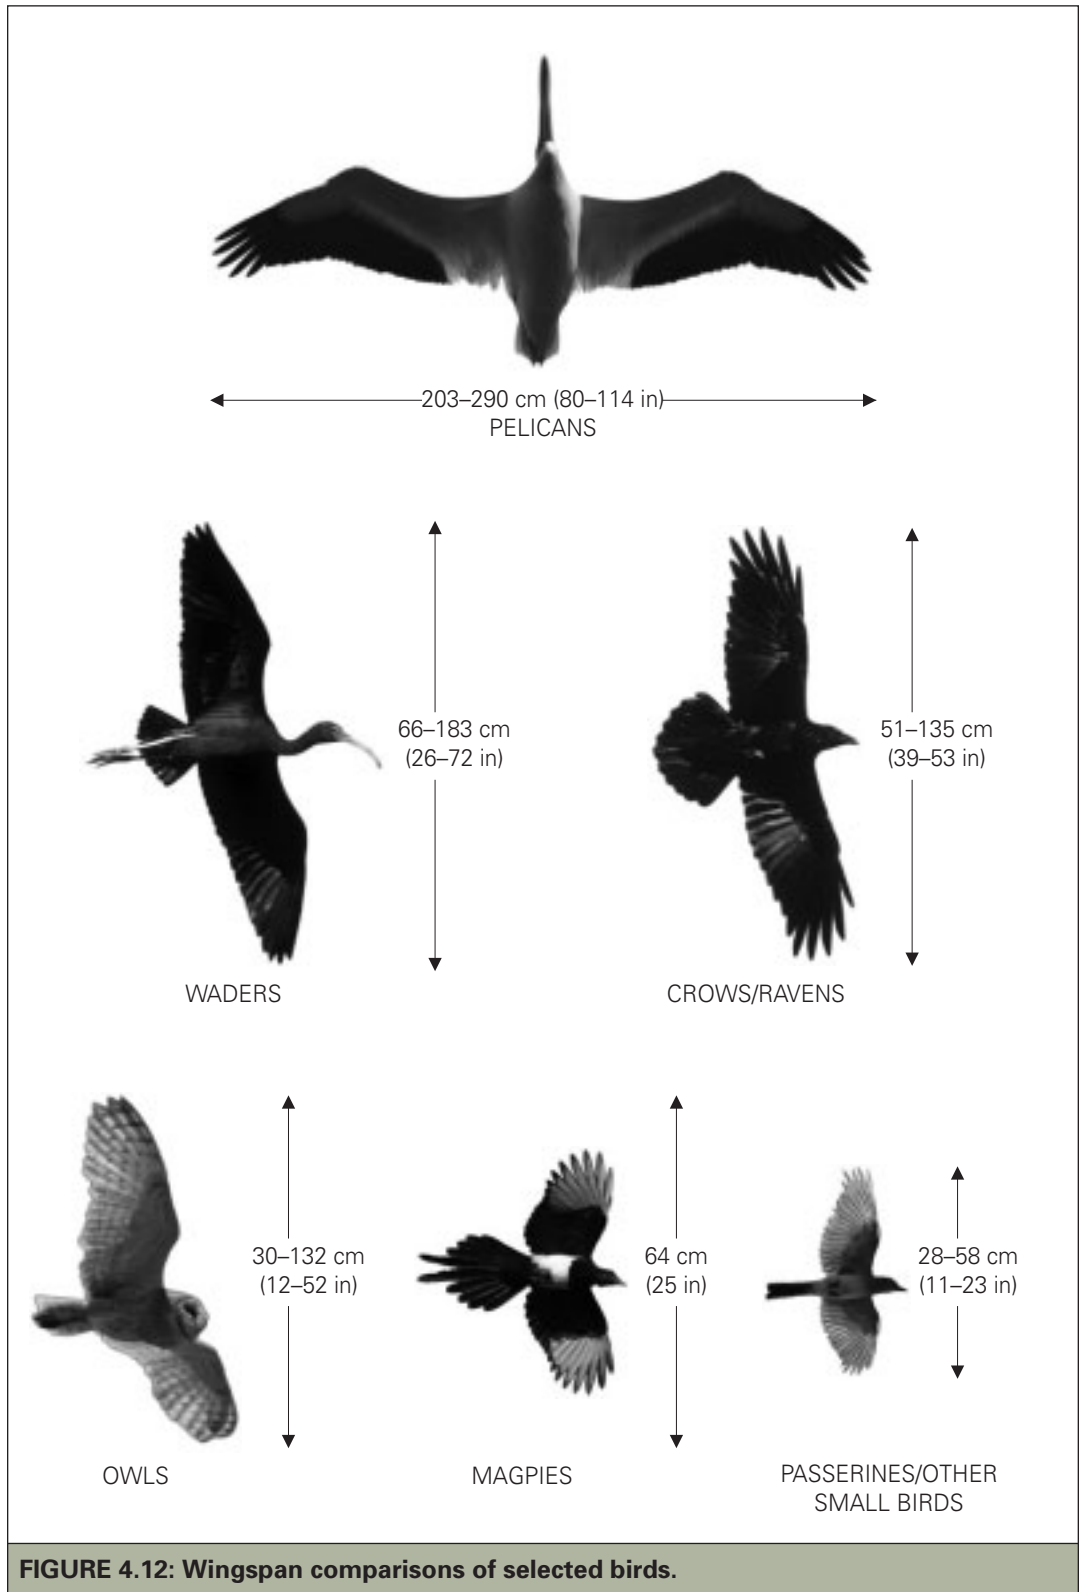
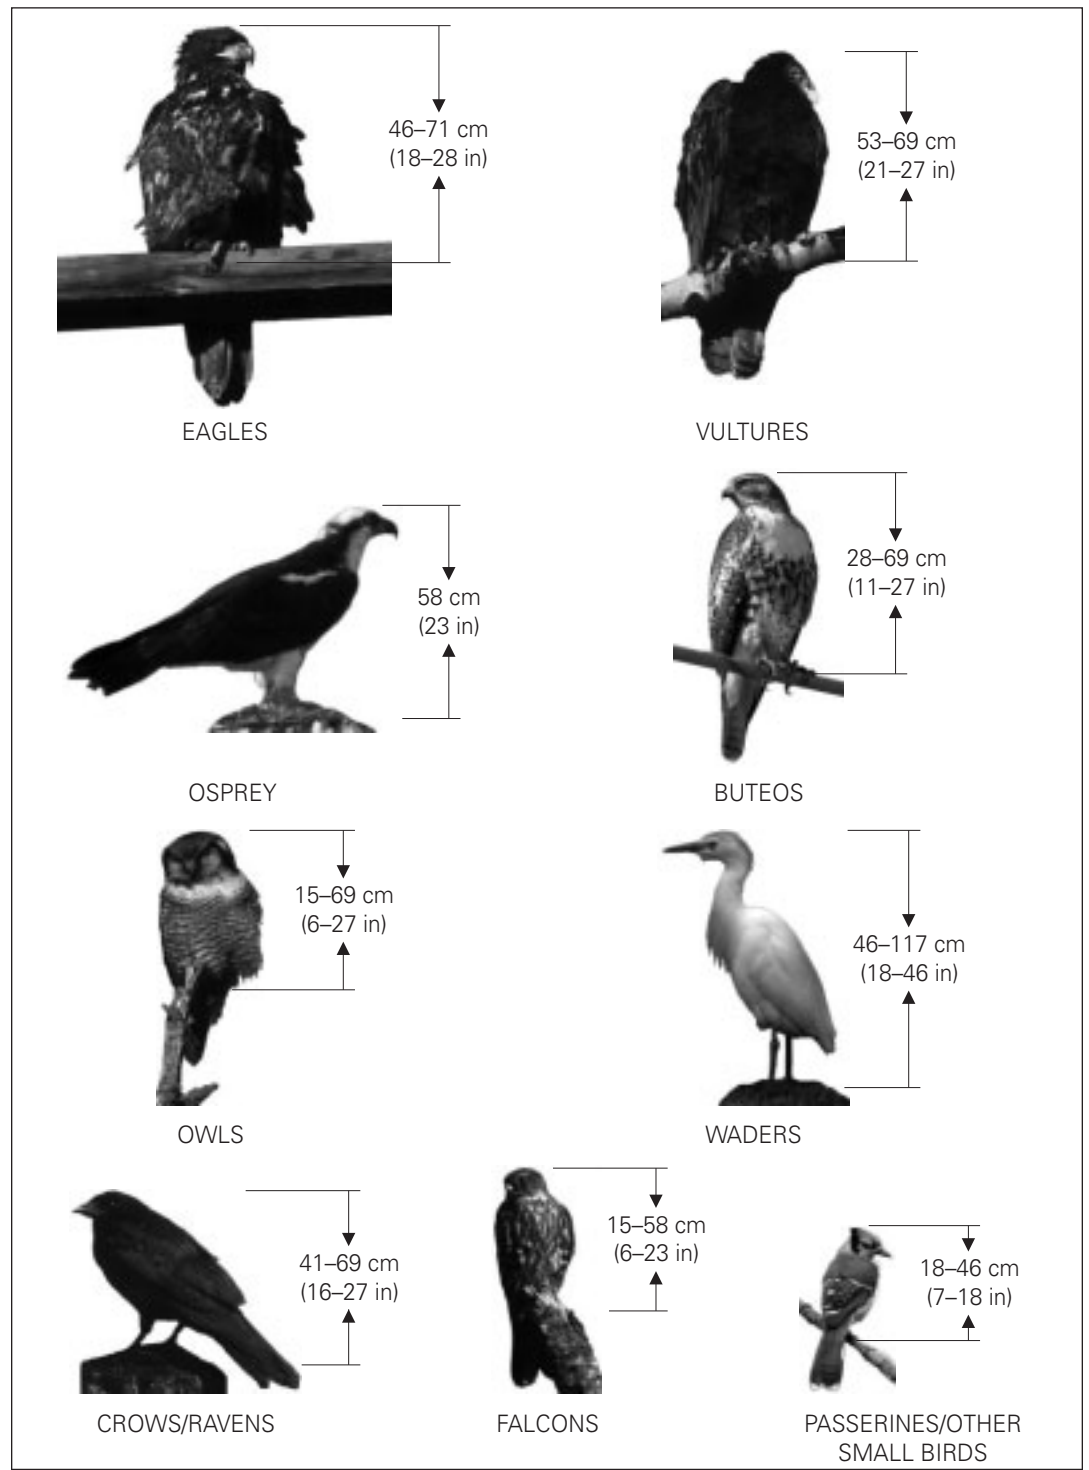
**FIGURE 4.13: Height comparisons of perched birds.<sup>18</sup>**

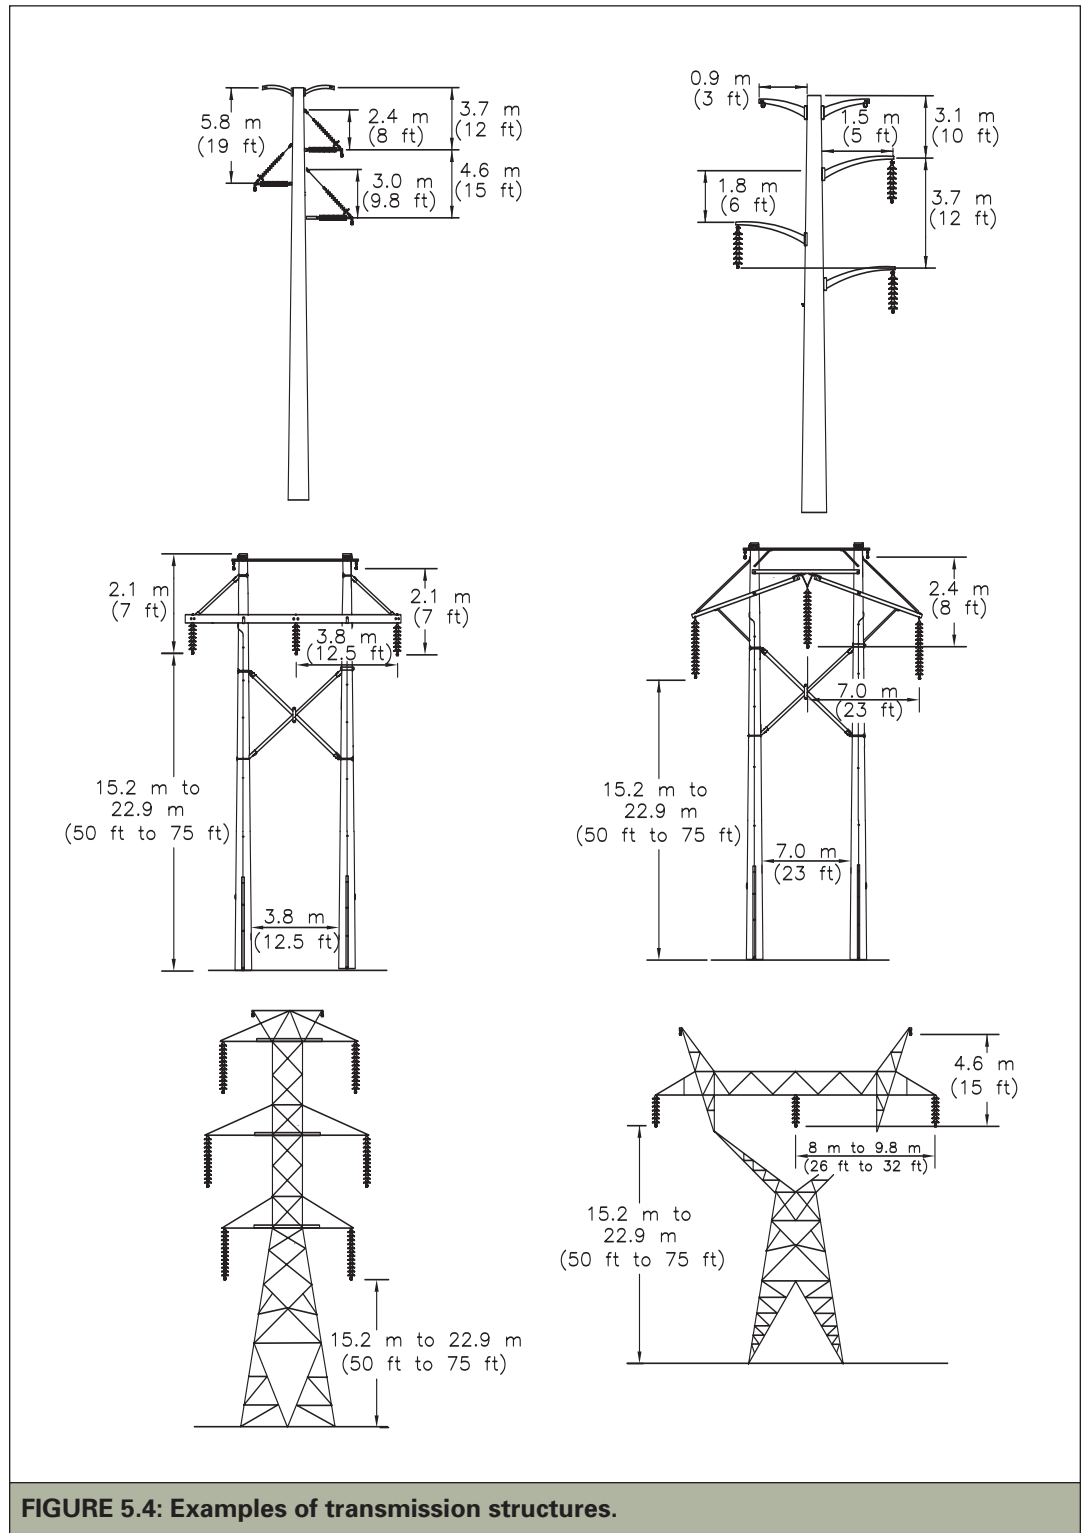
**FIGURE 5.4: Examples of transmission structures.**

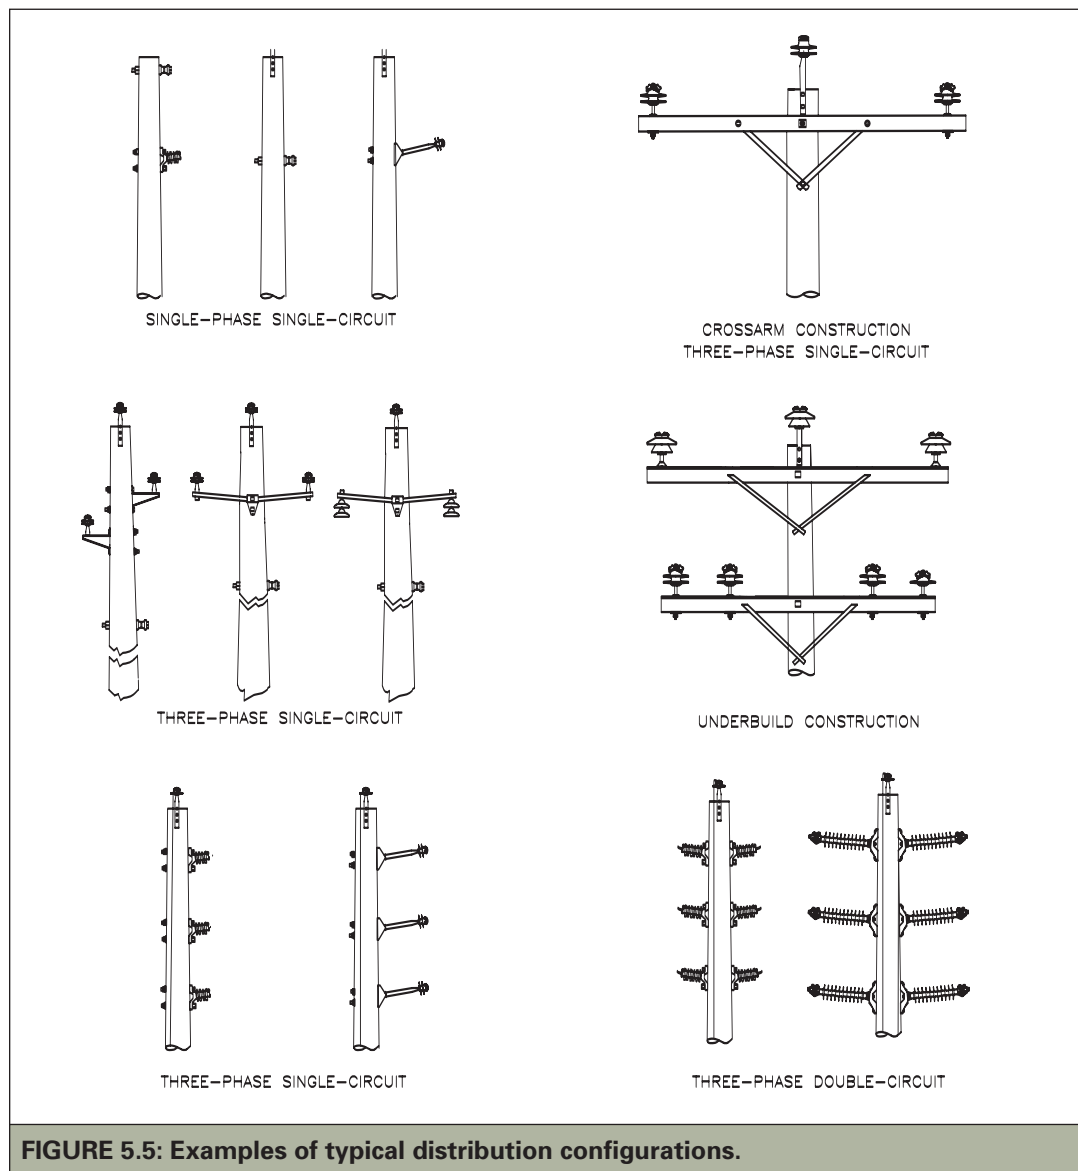
**FIGURE 5.5:** Examples of typical distribution configurations.

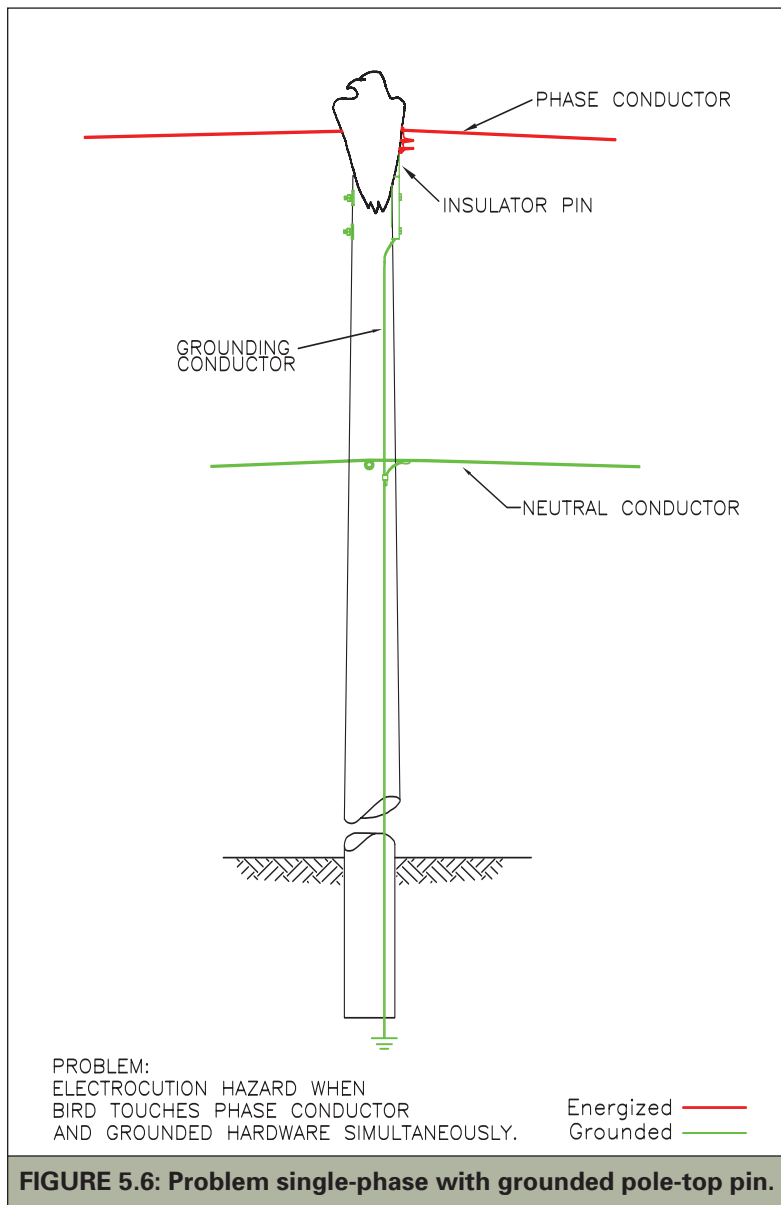
**FIGURE 5.6: Problem single-phase with grounded pole-top pin.**

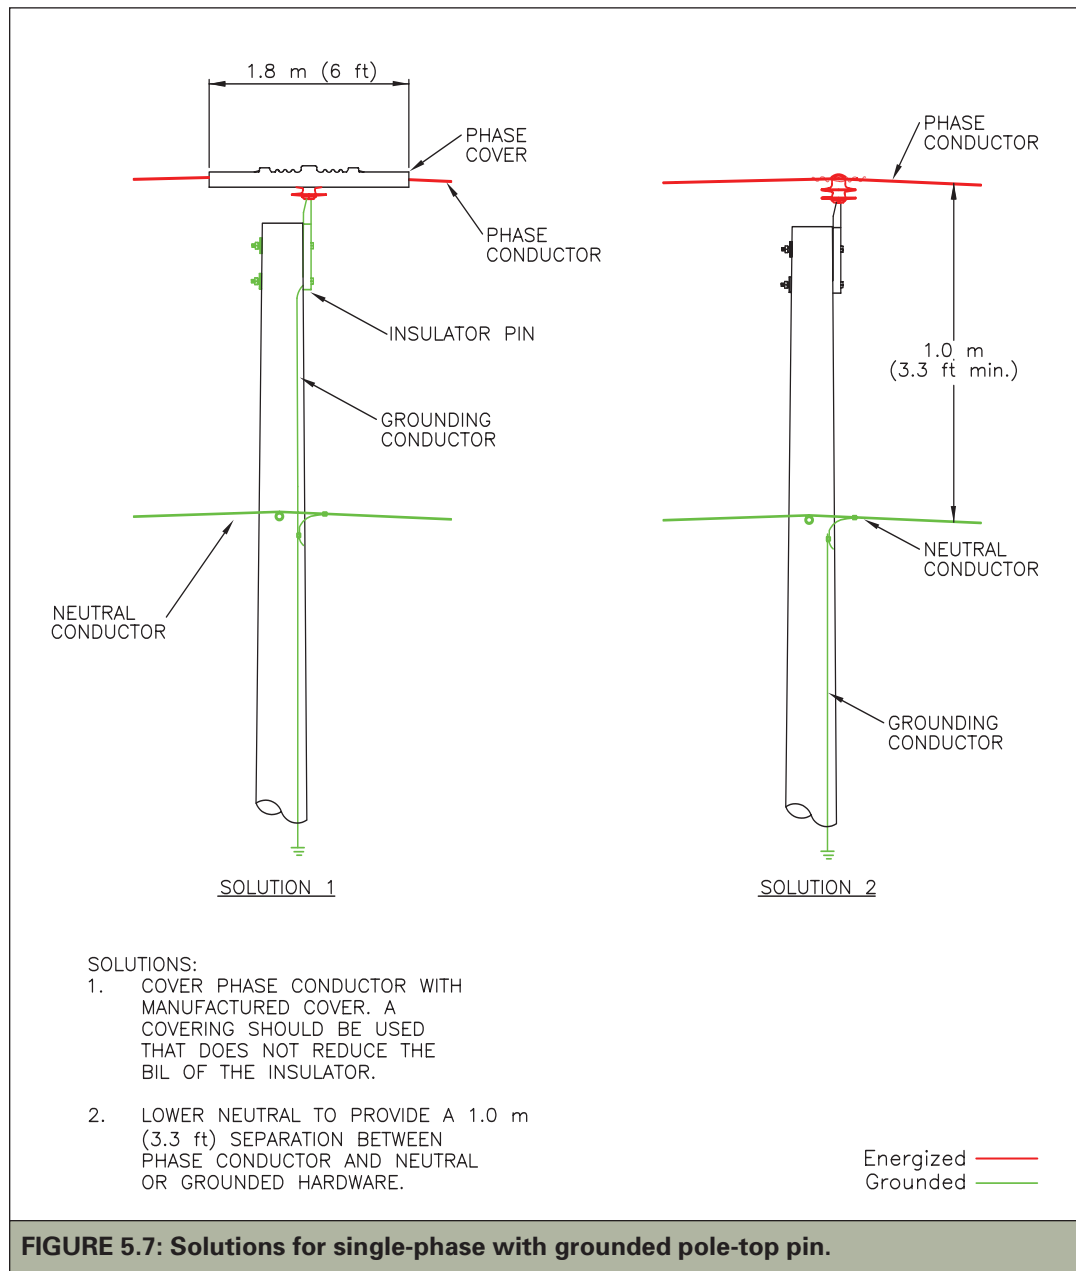
**FIGURE 5.7: Solutions for single-phase with grounded pole-top pin.**

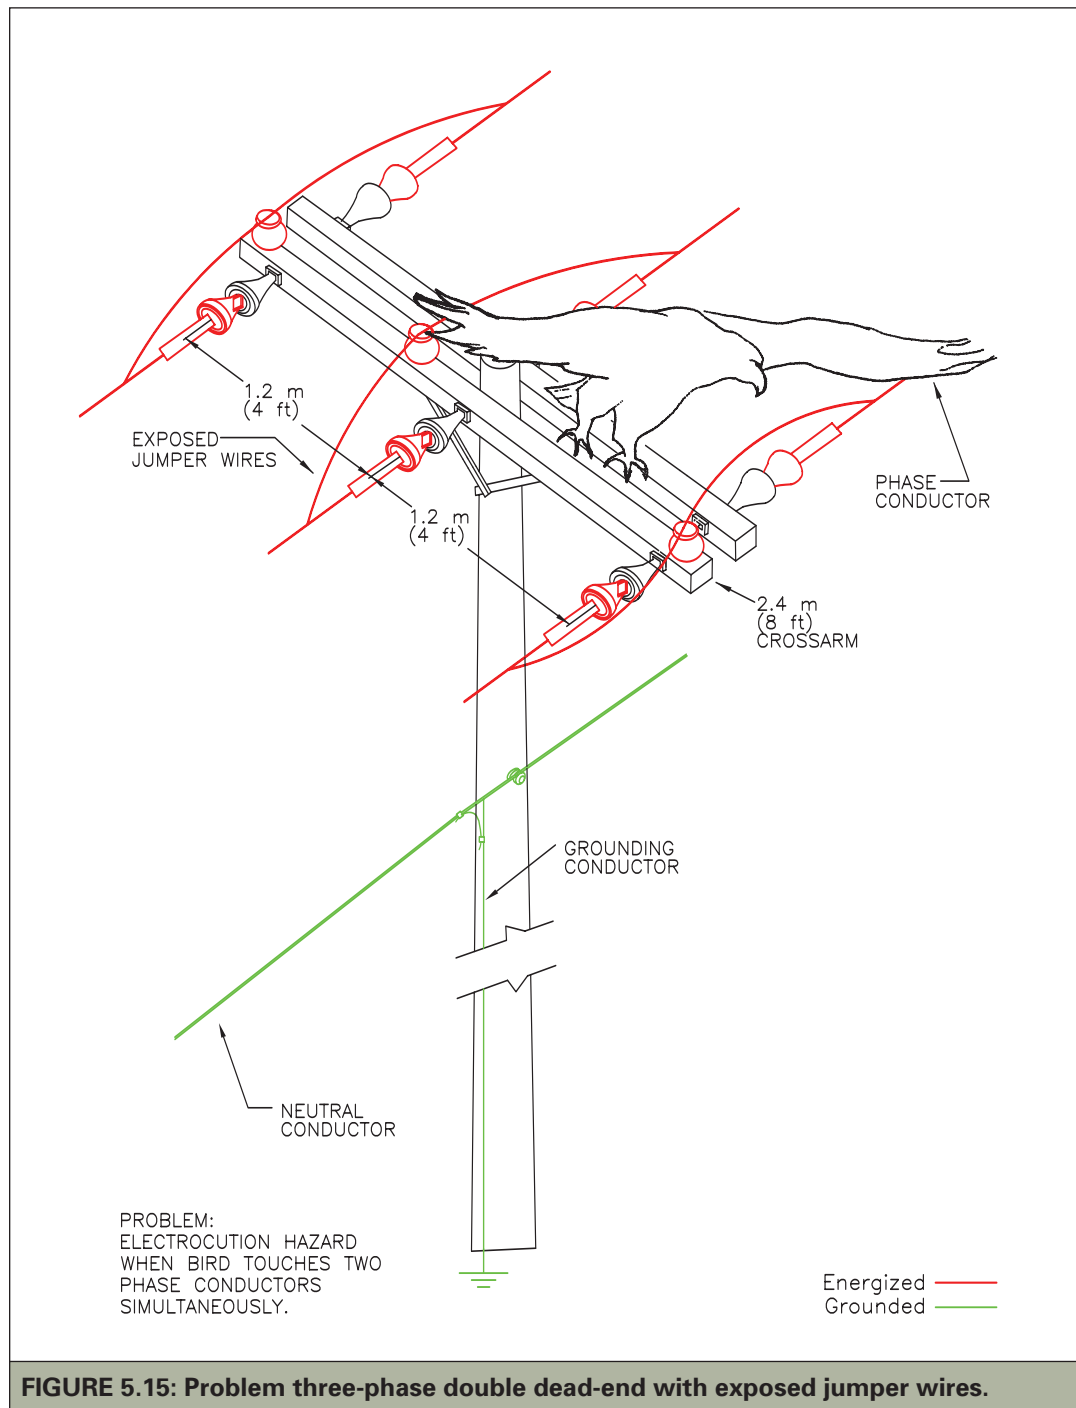
**FIGURE 5.15: Problem three-phase double dead-end with exposed jumper wires.**

configuration, a bird can be electrocuted by simultaneously touching two of the phase jumpers. To reduce this risk, use dead-end covers on both sides of the center conductor

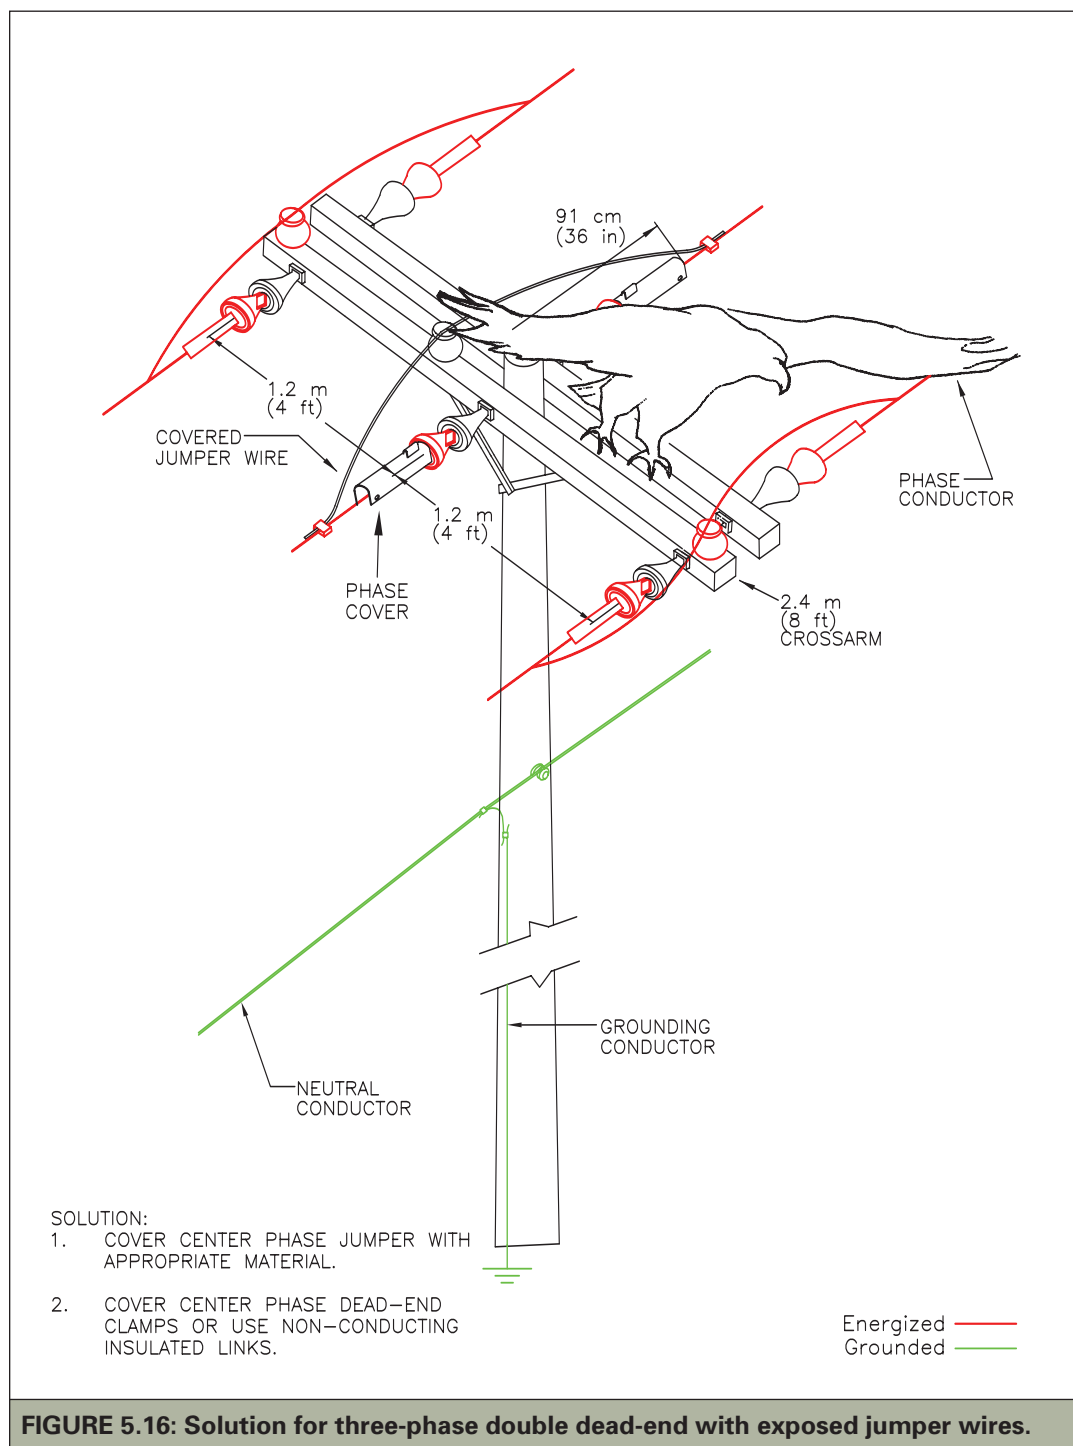
**FIGURE 5.16: Solution for three-phase double dead-end with exposed jumper wires.**

can insulated links or insulators that move the energized conductor 91 cm (36 in) from the center of the pole.

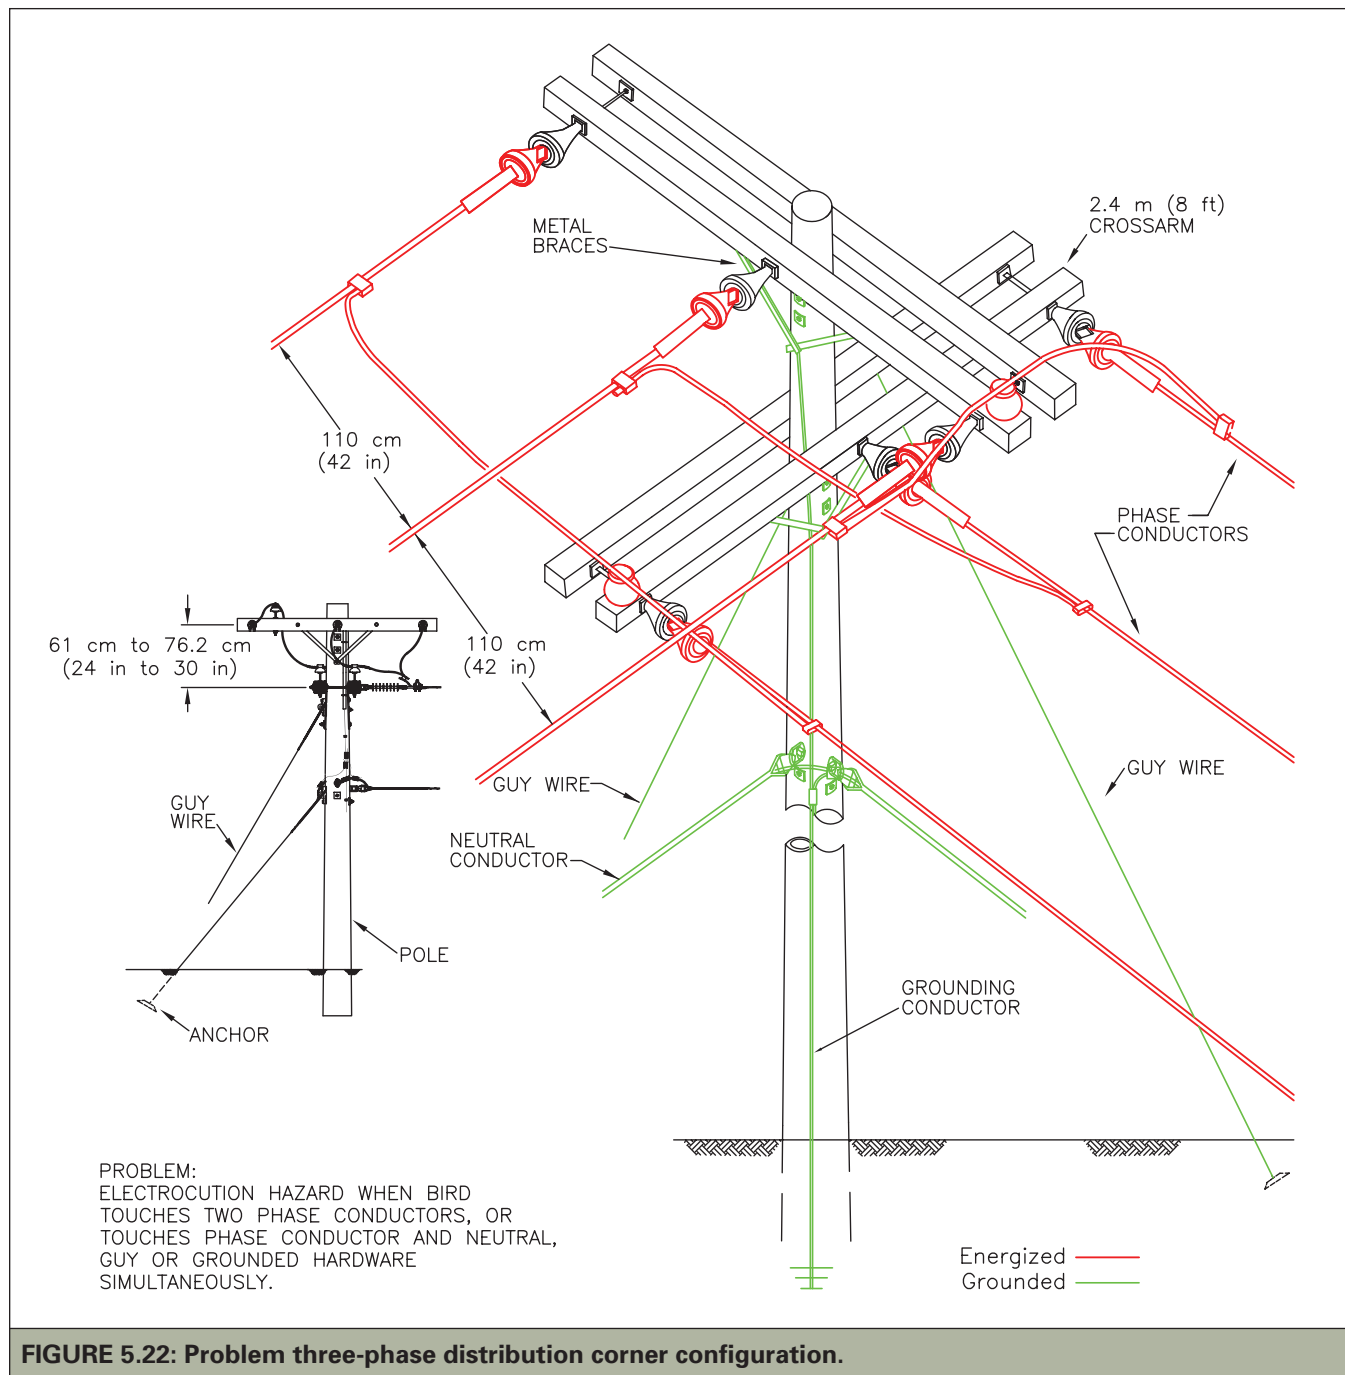
**FIGURE 5.22: Problem three-phase distribution corner configuration.**

On corner poles, the center phase conductor can be attached to the top set of crossarms with additional insulators or

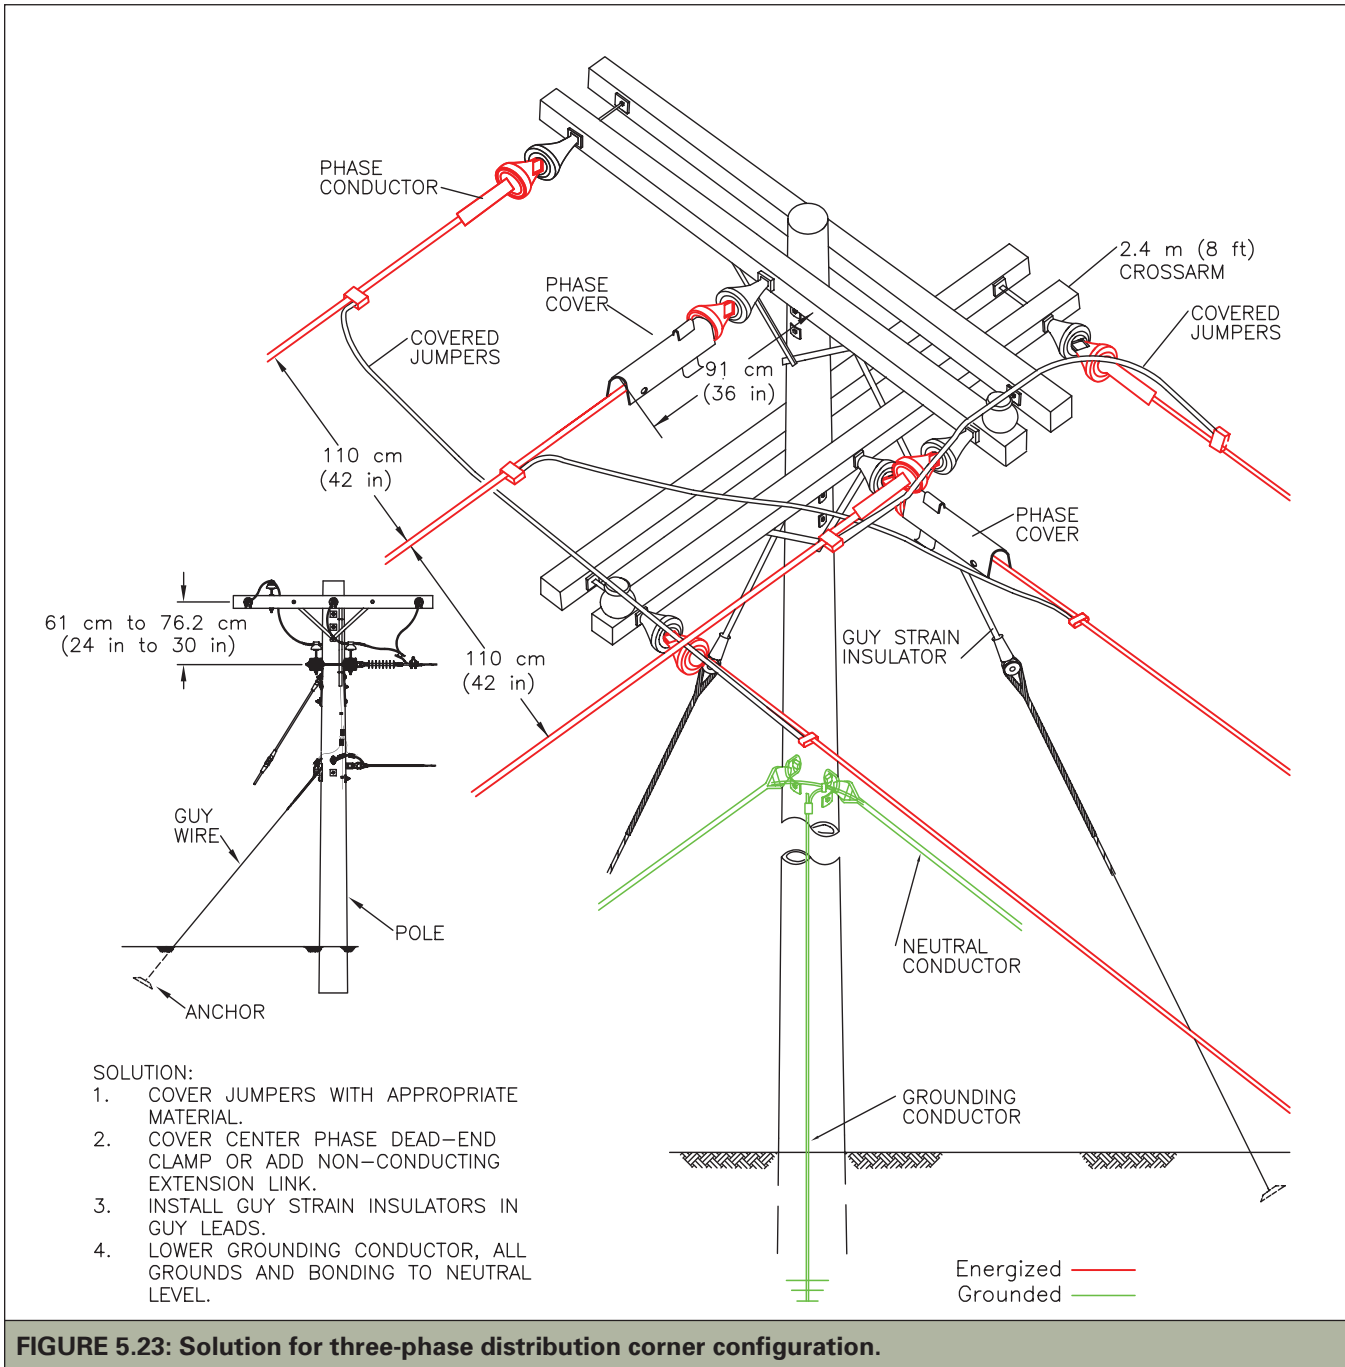
**FIGURE 5.23: Solution for three-phase distribution corner configuration.**

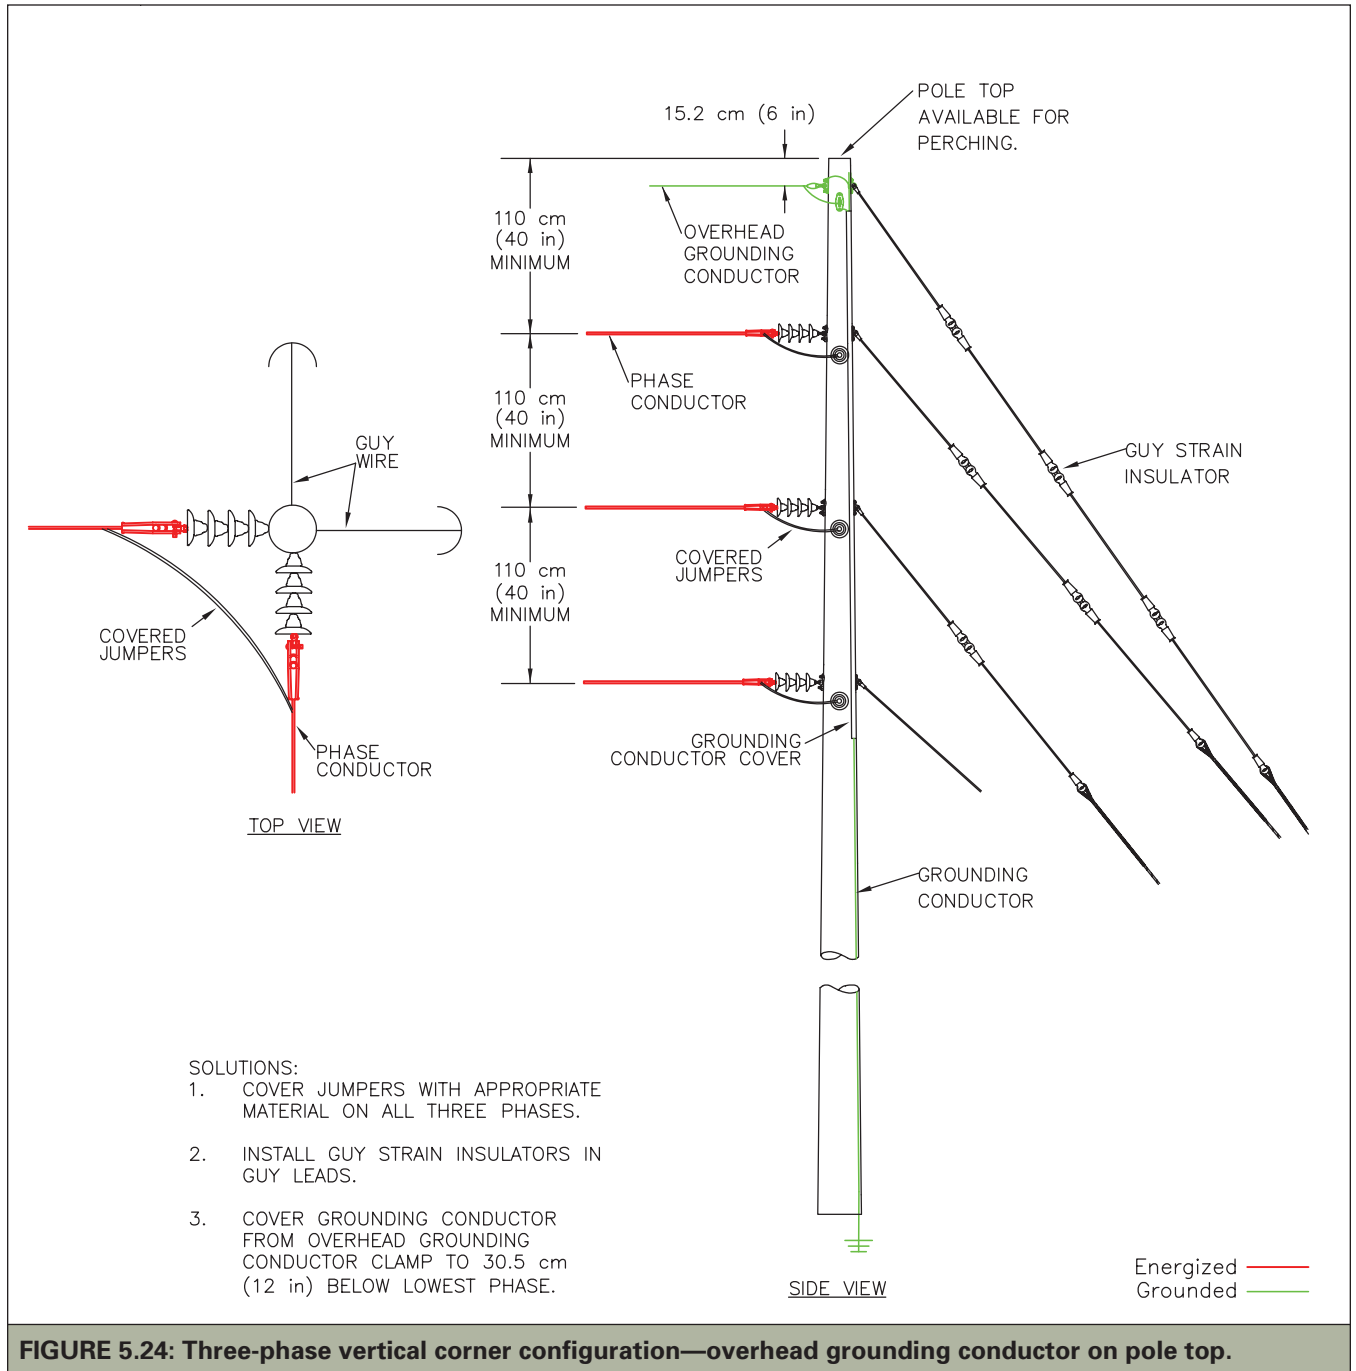
**FIGURE 5.24: Three-phase vertical corner configuration—overhead grounding conductor on pole top.**

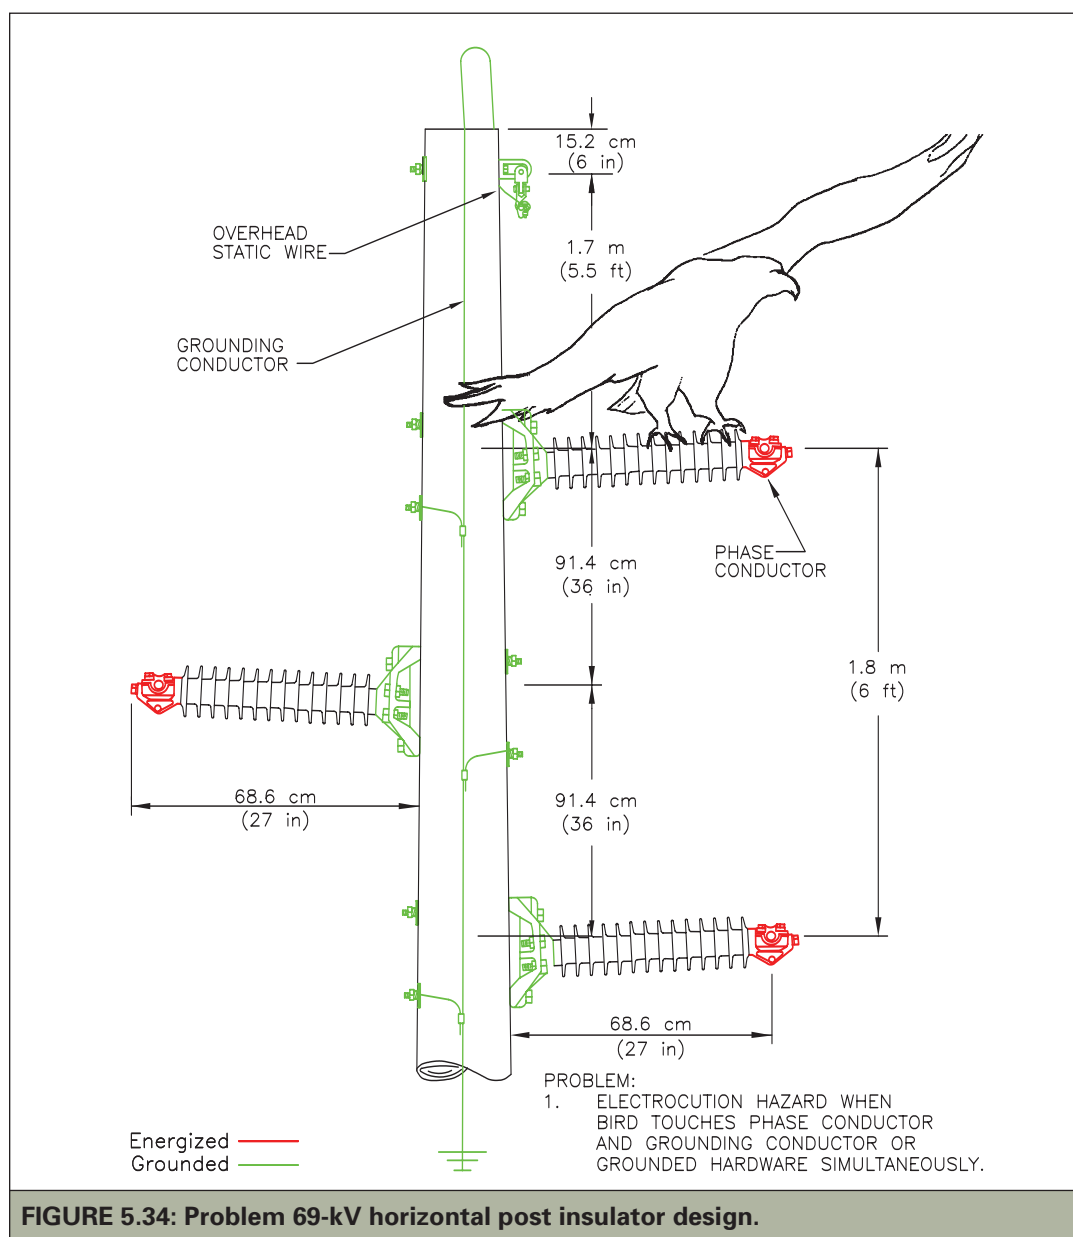
**FIGURE 5.34: Problem 69-kV horizontal post insulator design.**

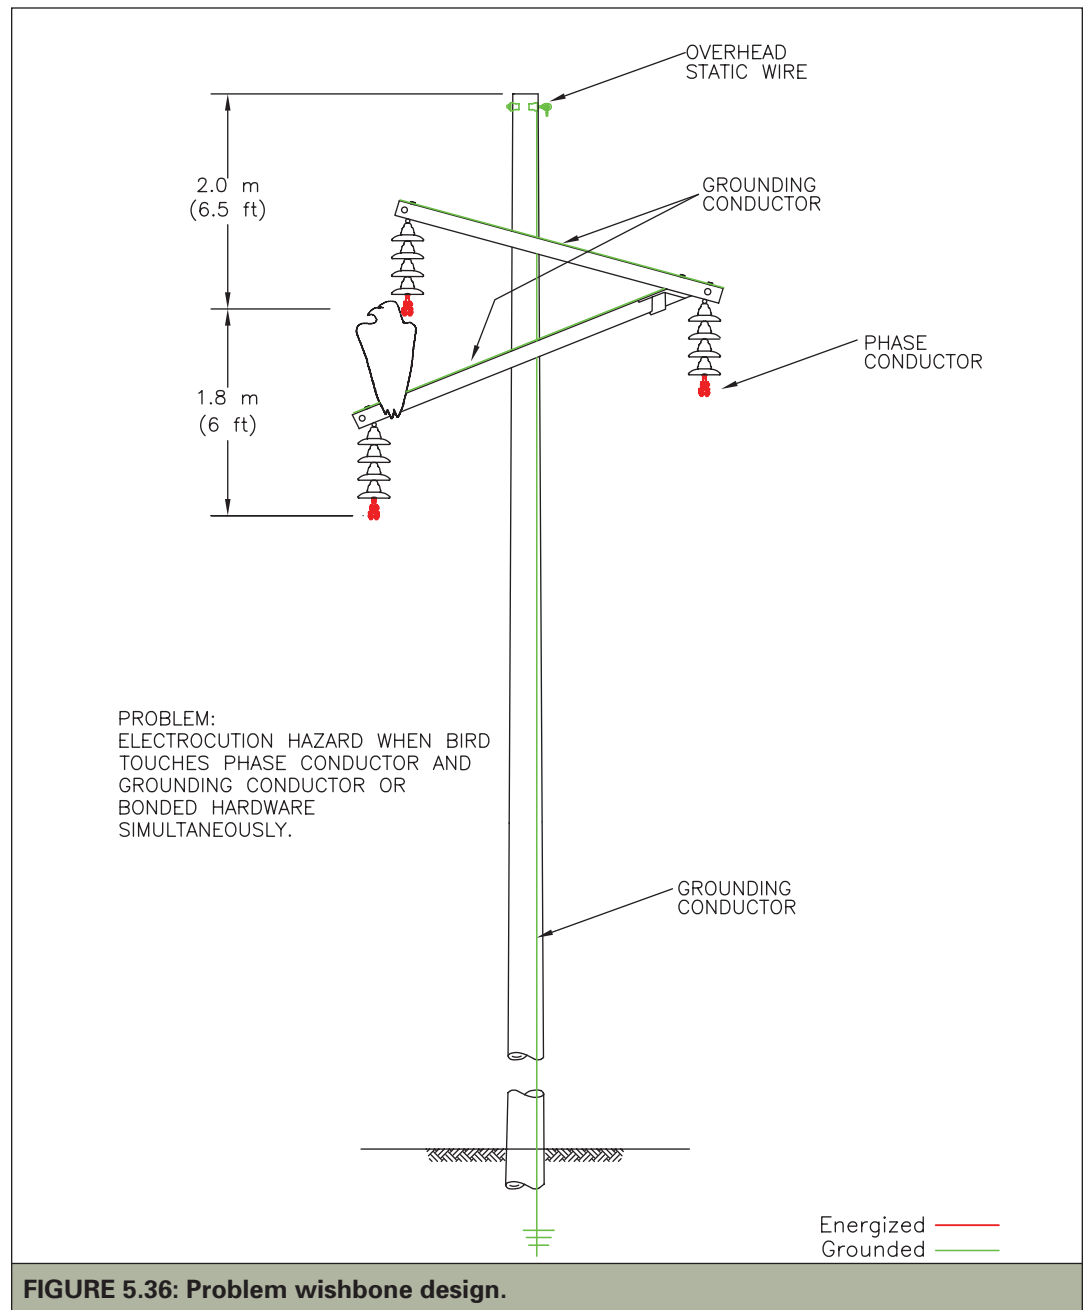
**FIGURE 5.36: Problem wishbone design.**
