# Suggested Practices for Avian Protection On Power Lines: The State of the Art in 2006

PIER FINAL PROJECT REPORT CEC-500-2006-022

Avian  
Power  
Line  
Interaction  
Committee

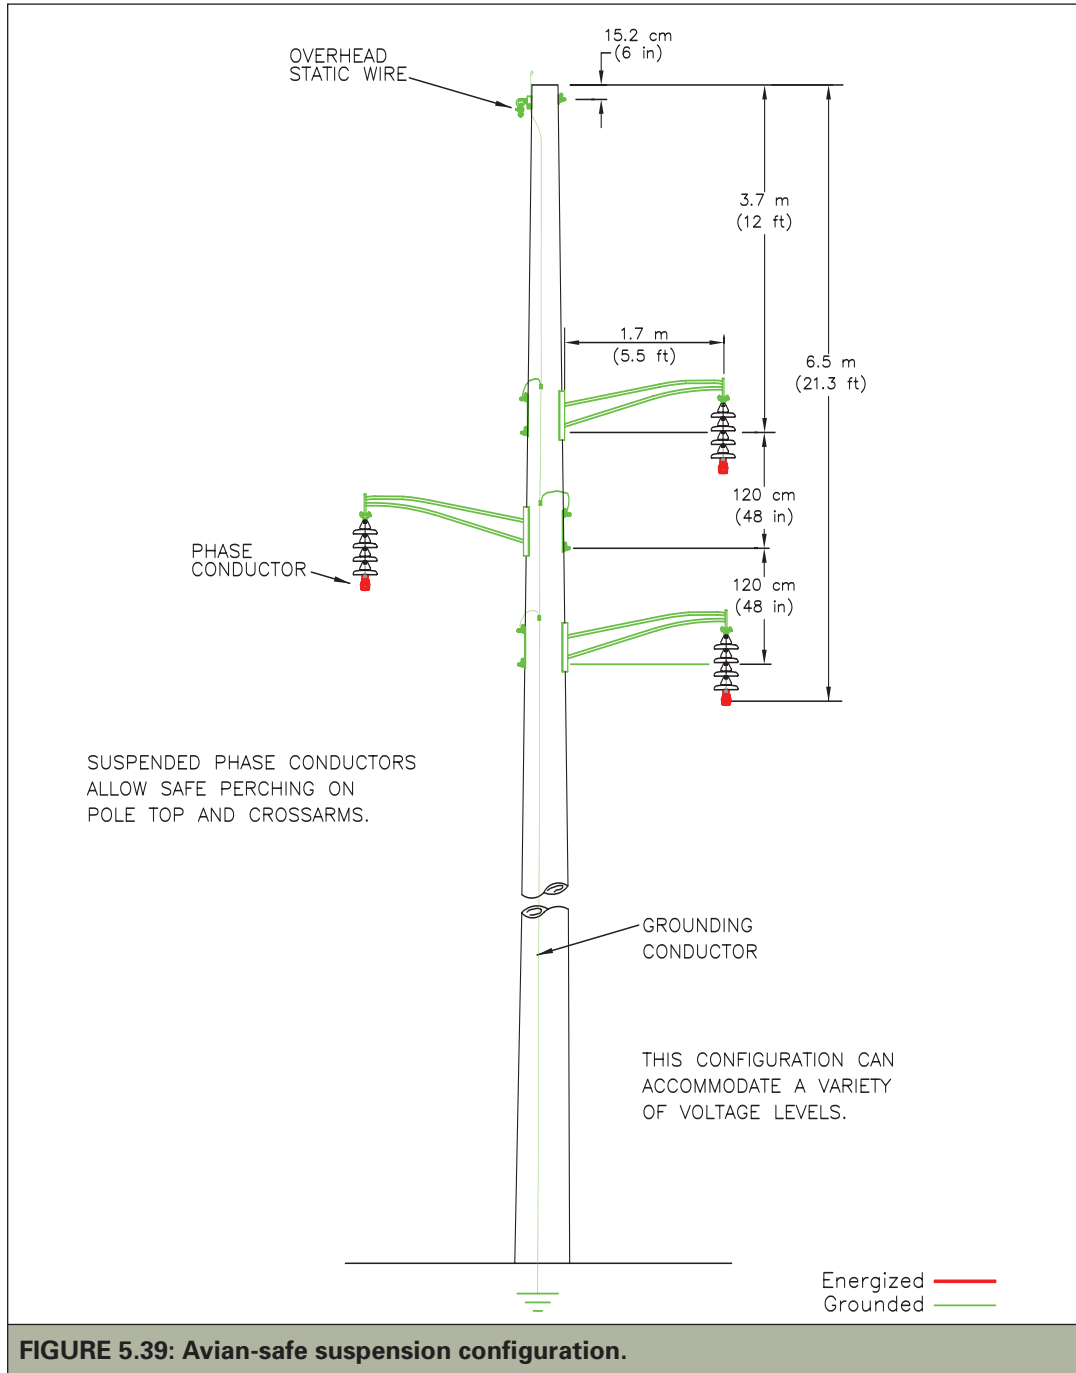
**FIGURE 5.39: Avian-safe suspension configuration.**

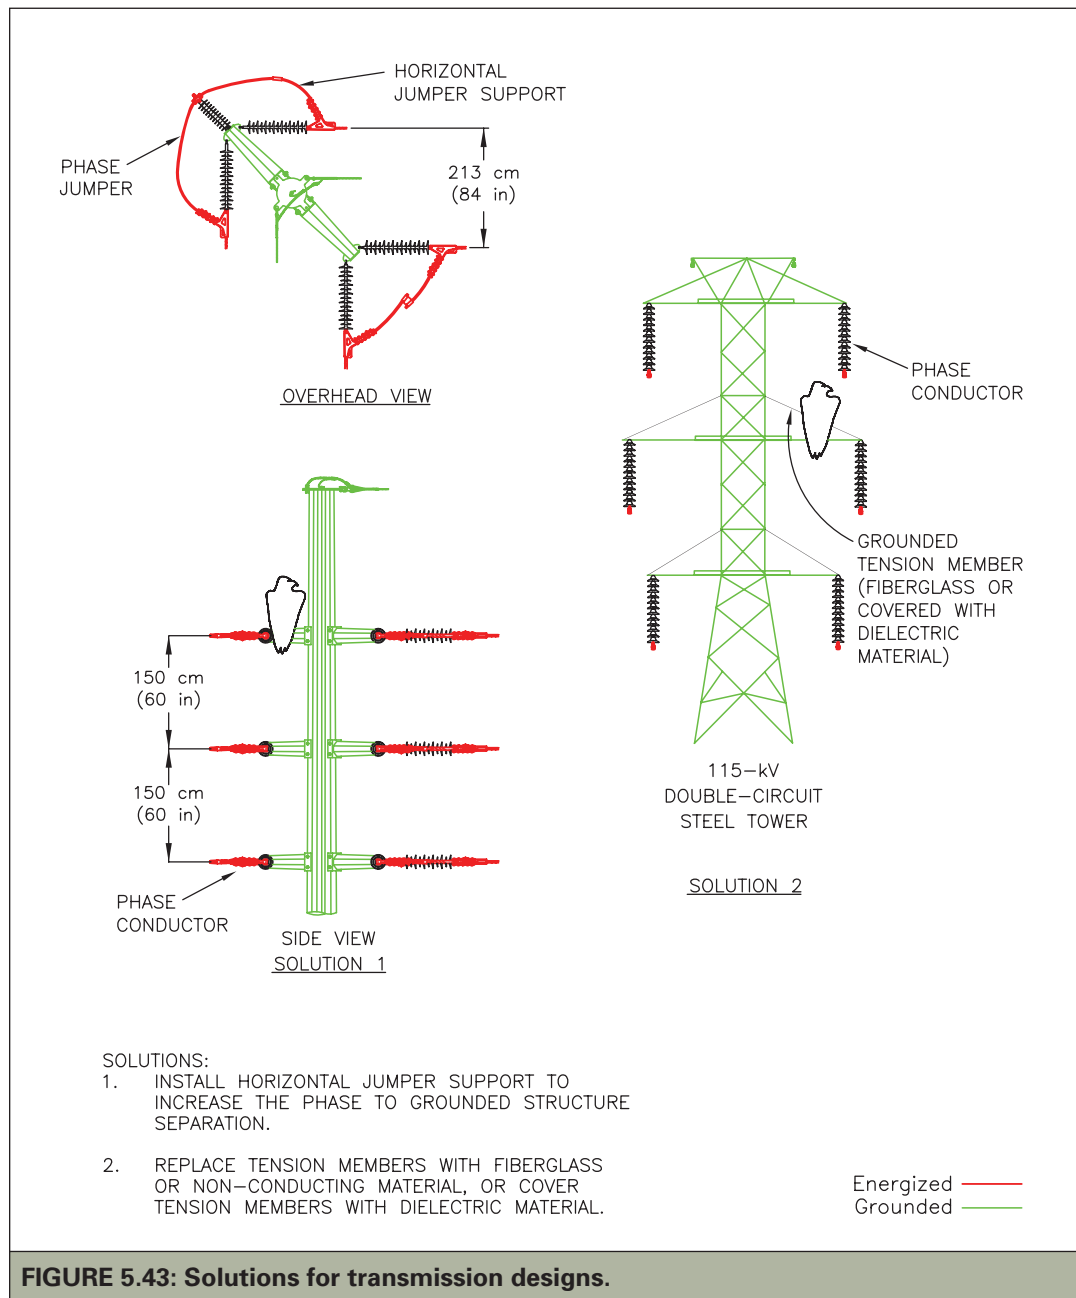
**FIGURE 5.43: Solutions for transmission designs.**

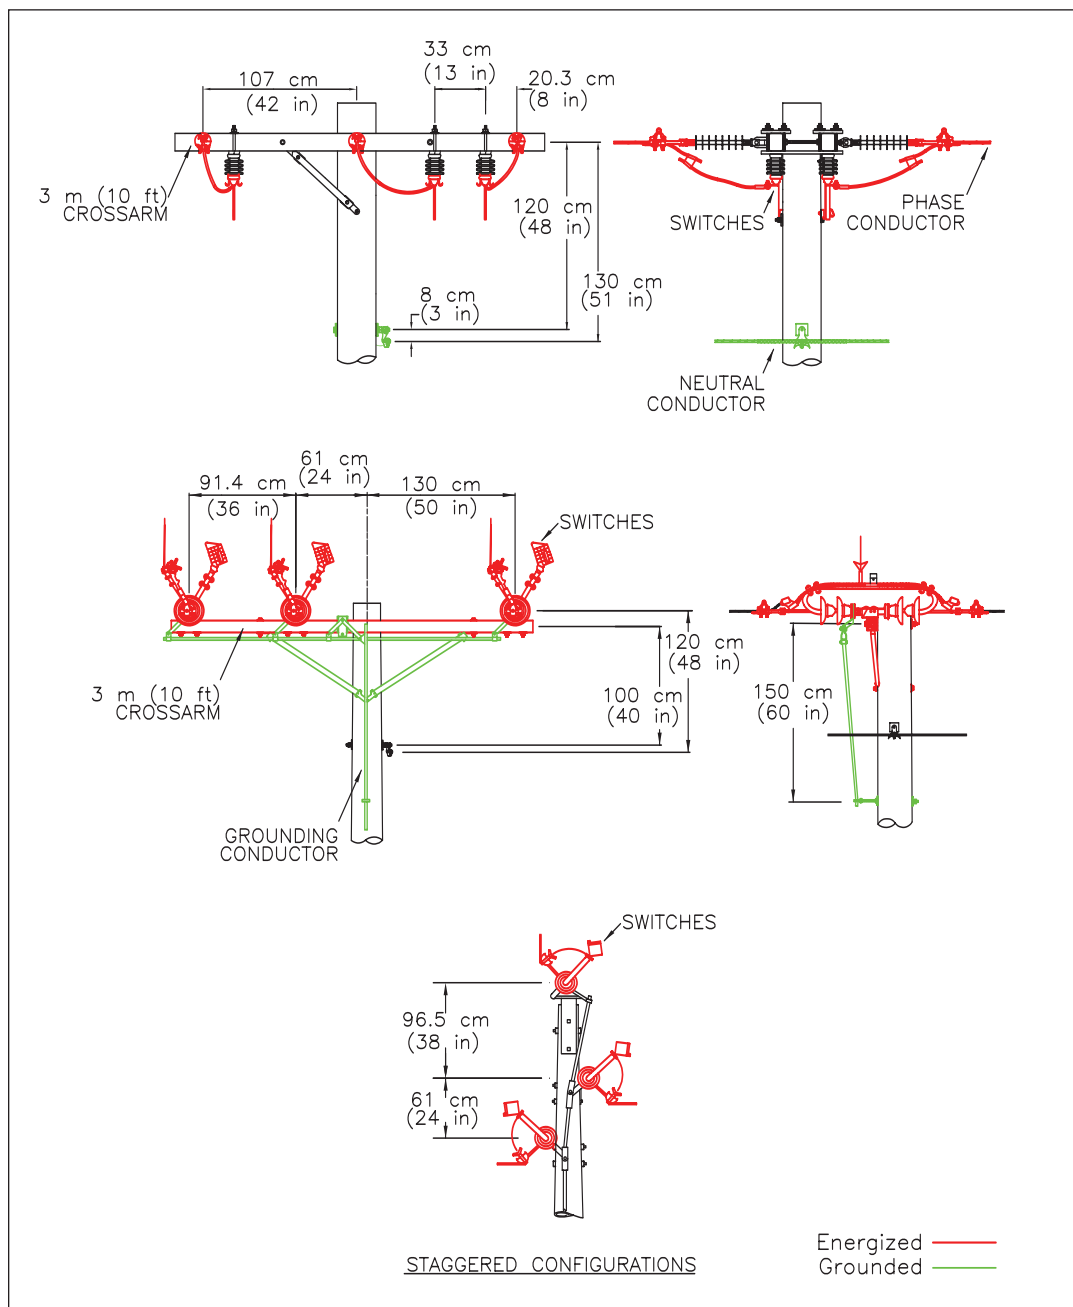
**FIGURE 5.48: Pole-mounted switches.**

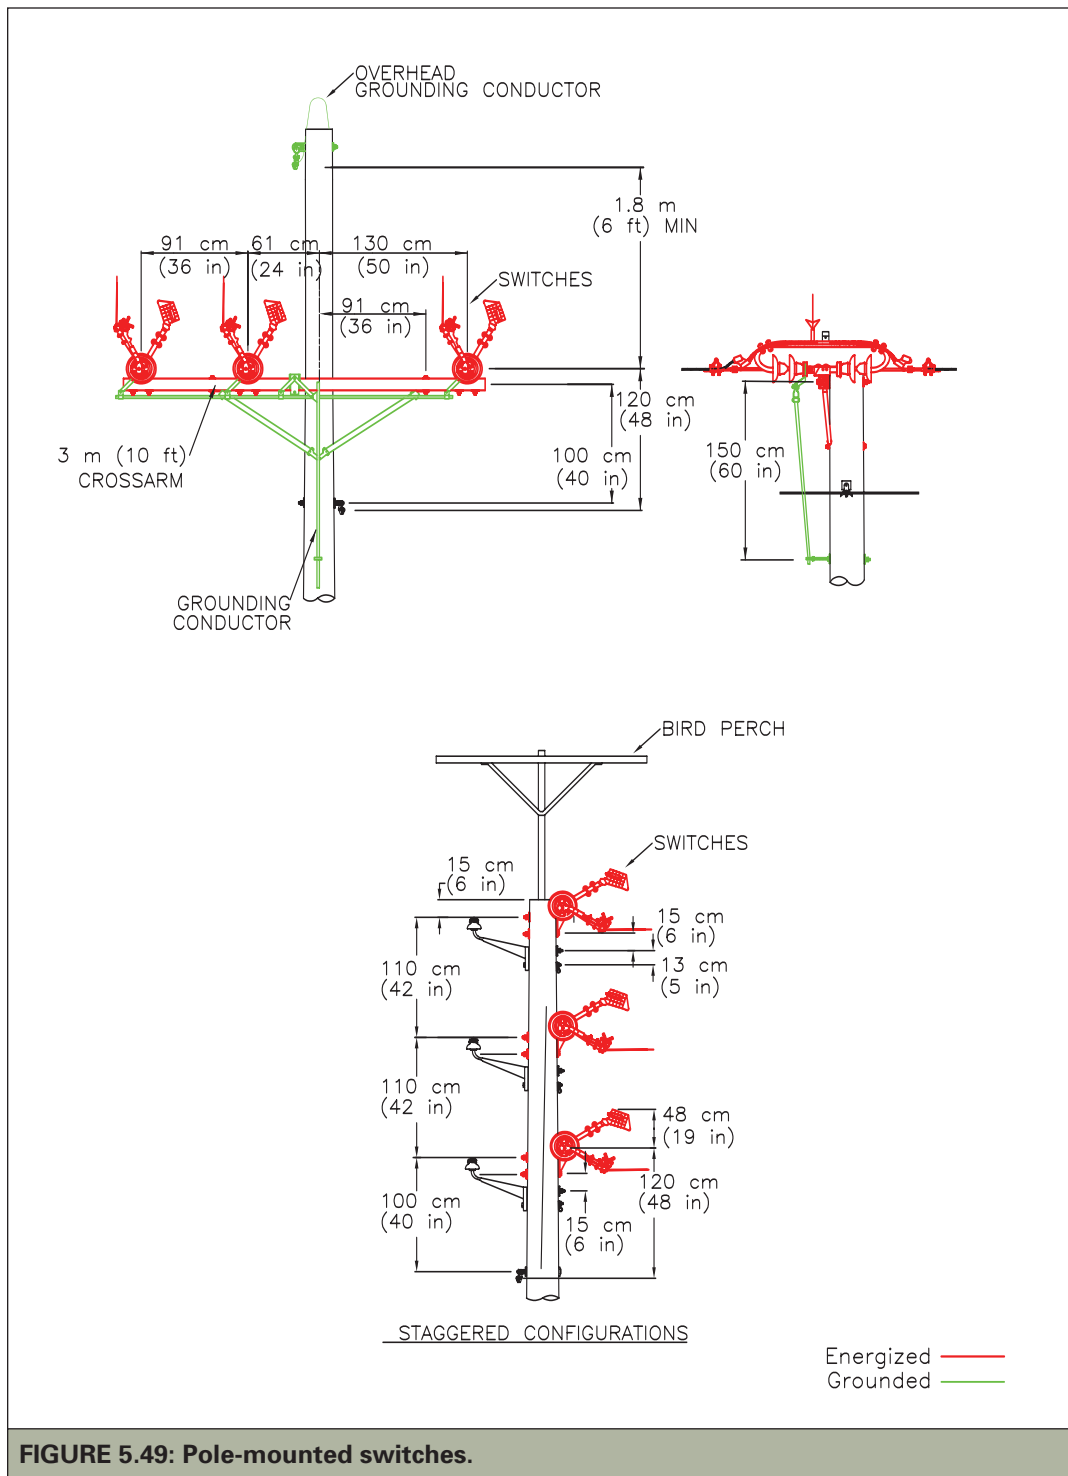
**FIGURE 5.49: Pole-mounted switches.**

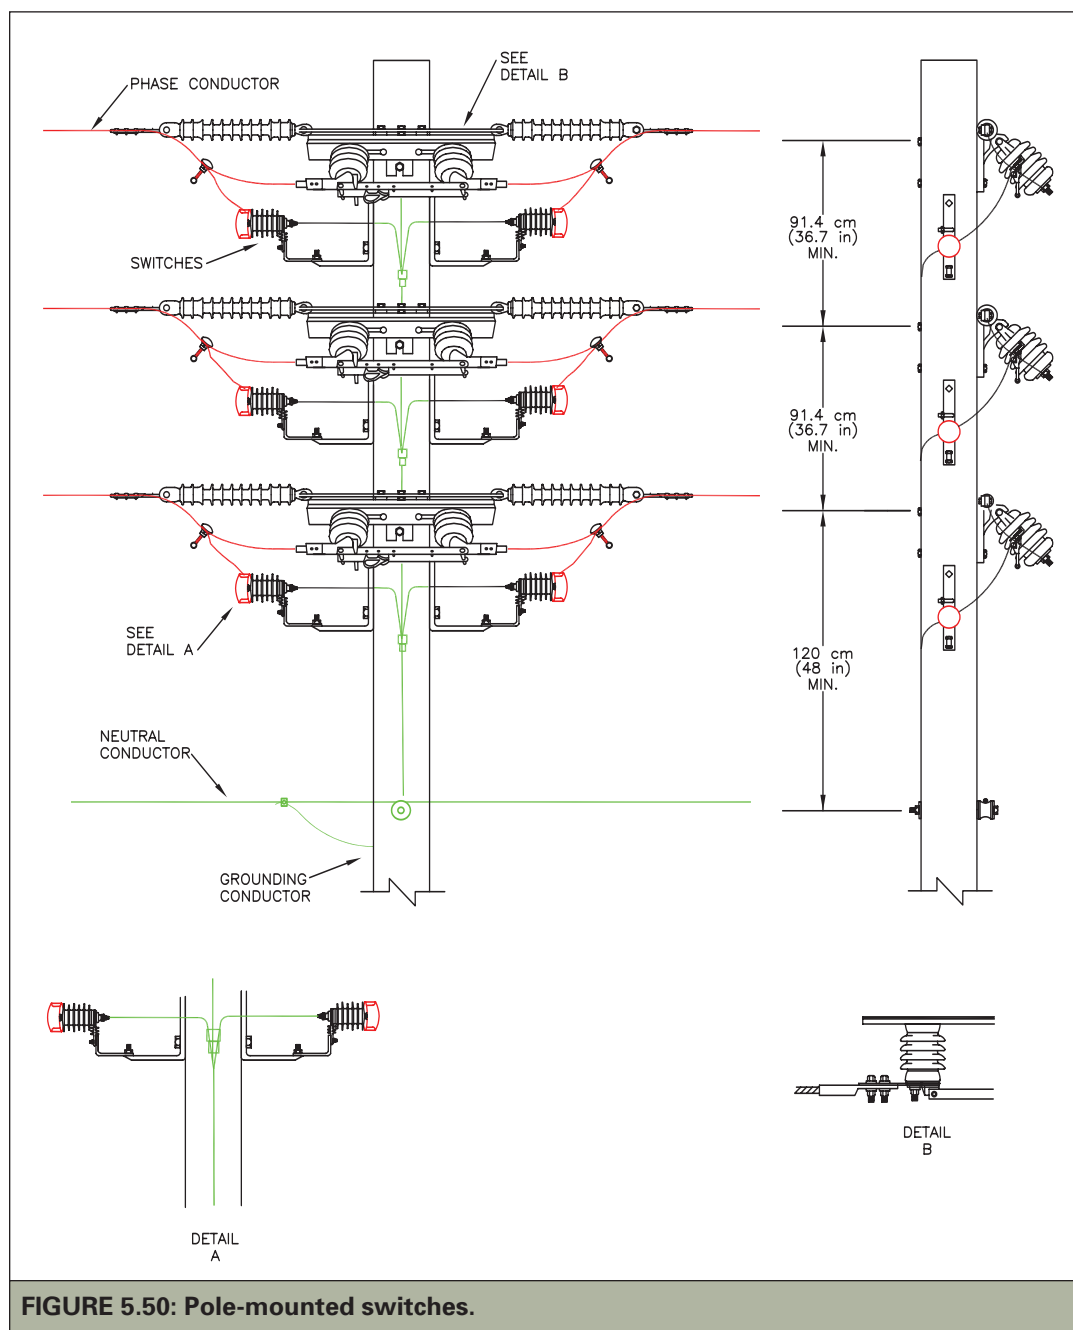
**FIGURE 5.50: Pole-mounted switches.**

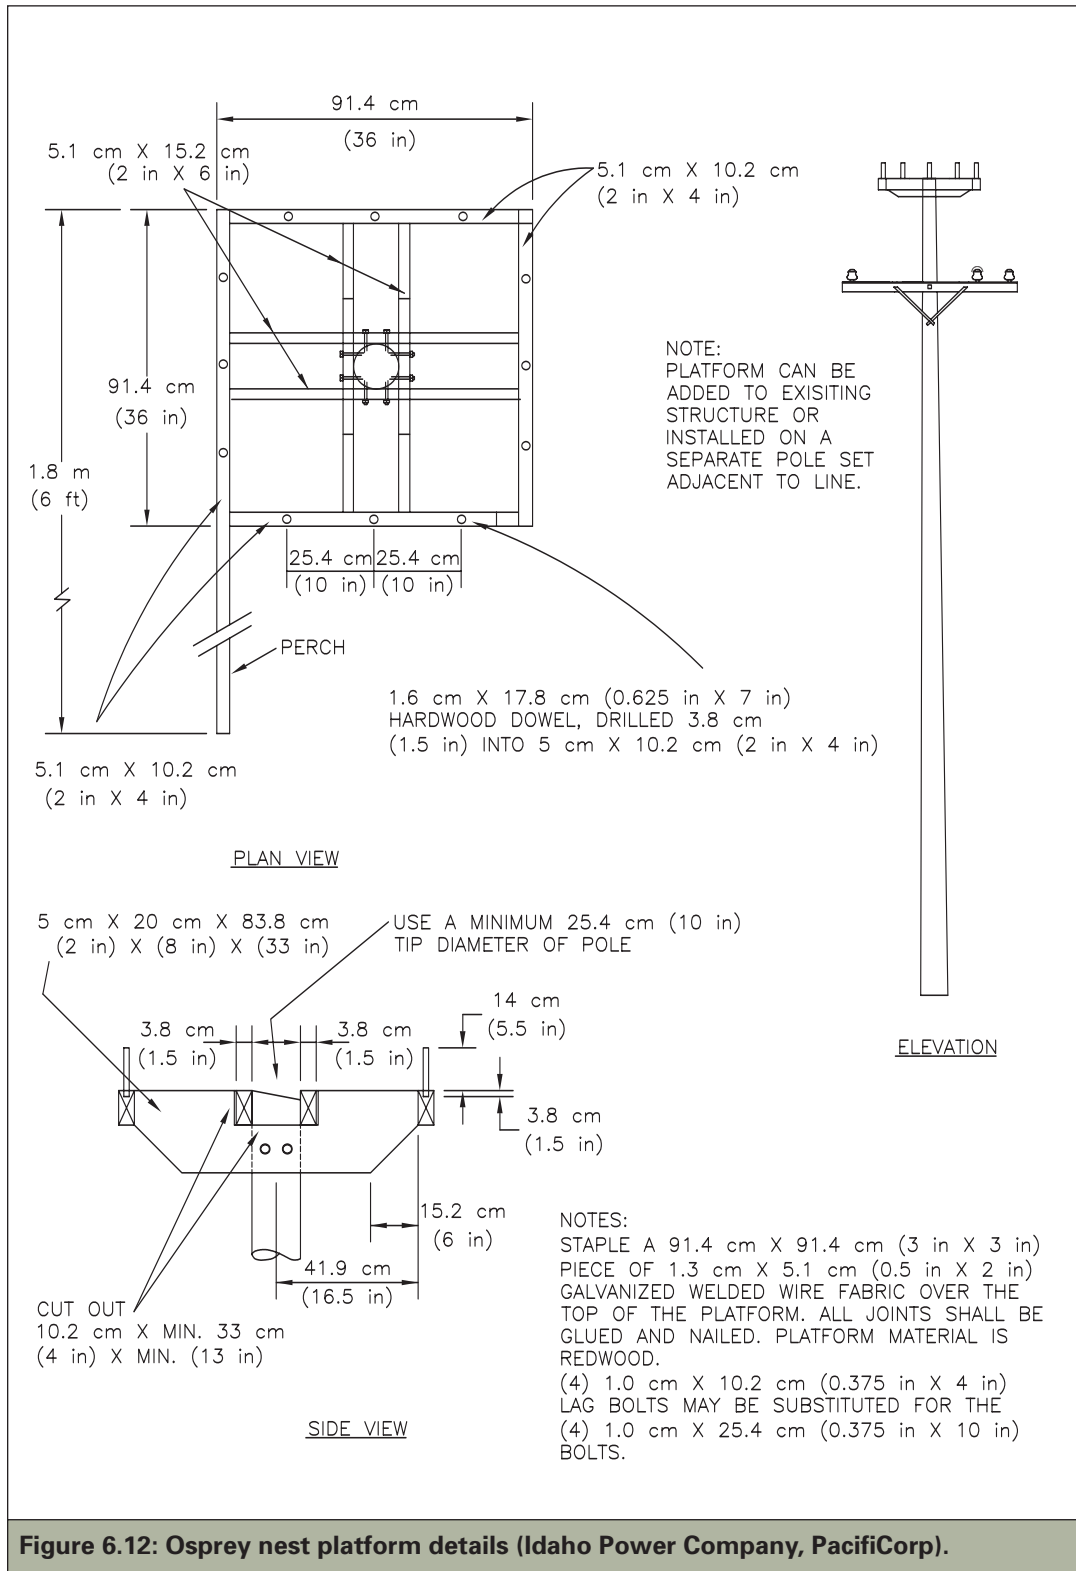
Figure 6.12: Osprey nest platform details (Idaho Power Company, PacifiCorp).

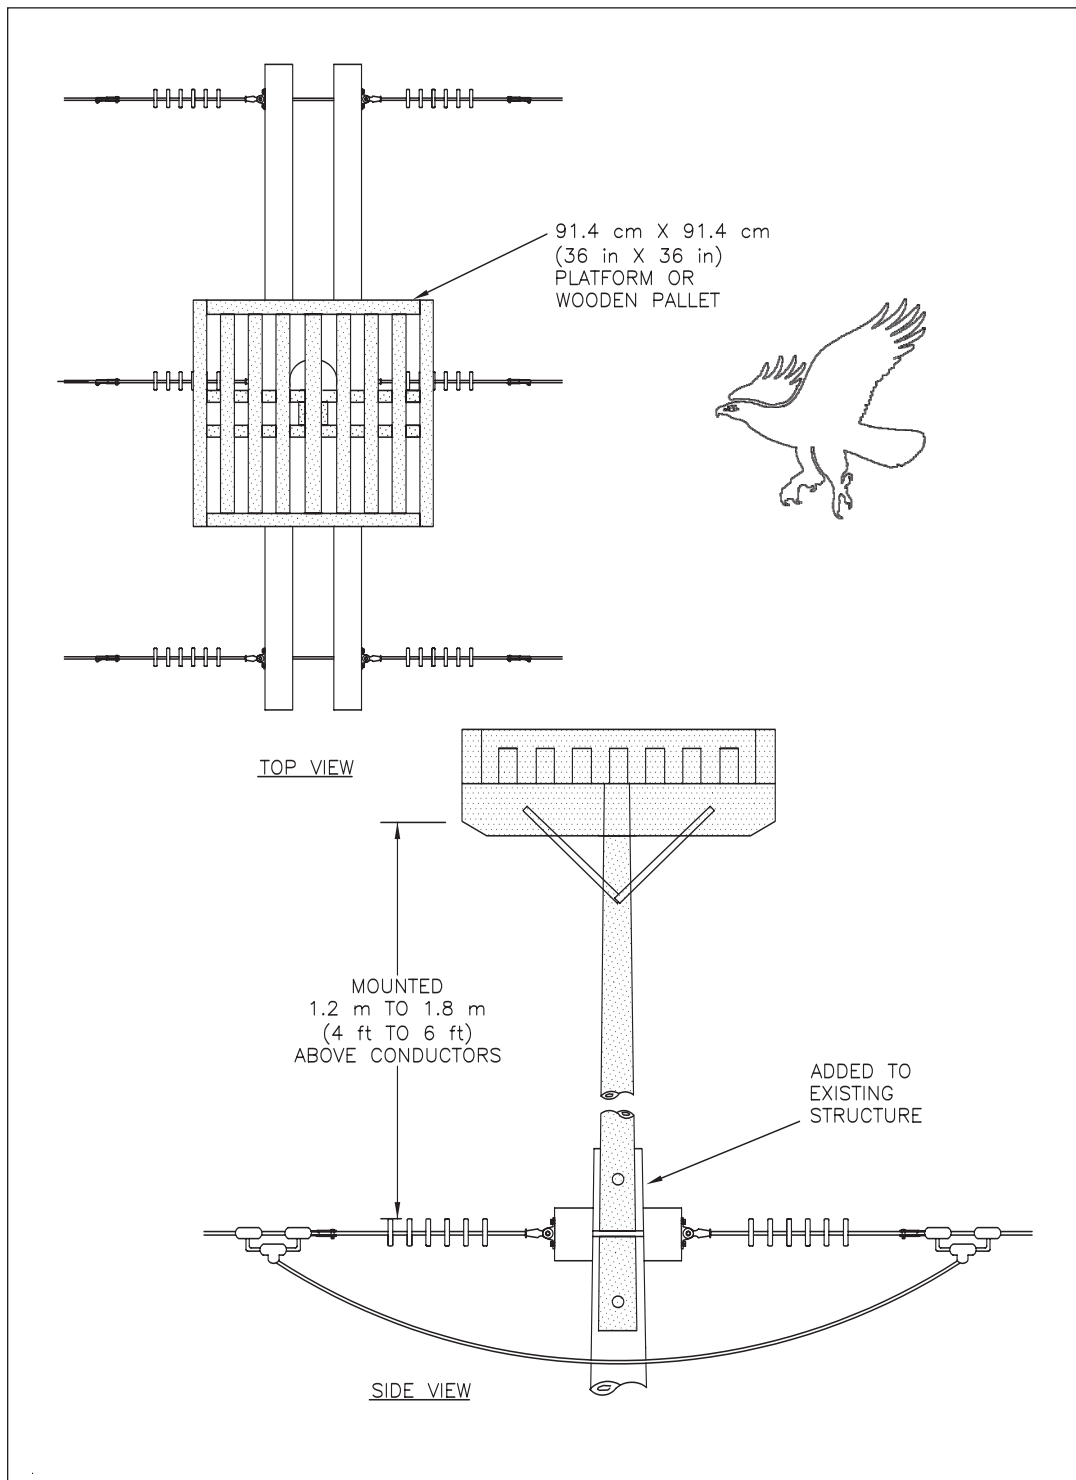
**FIGURE 6.15: Raptor nest platform used by ospreys and some buteos (PacifiCorp). This design is recommended when a new nest pole cannot be erected.**
